REPUBLIC OF TURKEY  
MINISTRY OF FORESTRY AND WATER AFFAIRS  
General Directorate of Combating Desertification and Erosion

# AĞRI DOĞUBAYAZIT FLOOD CONTROL WORKS

2017 - ANKARA

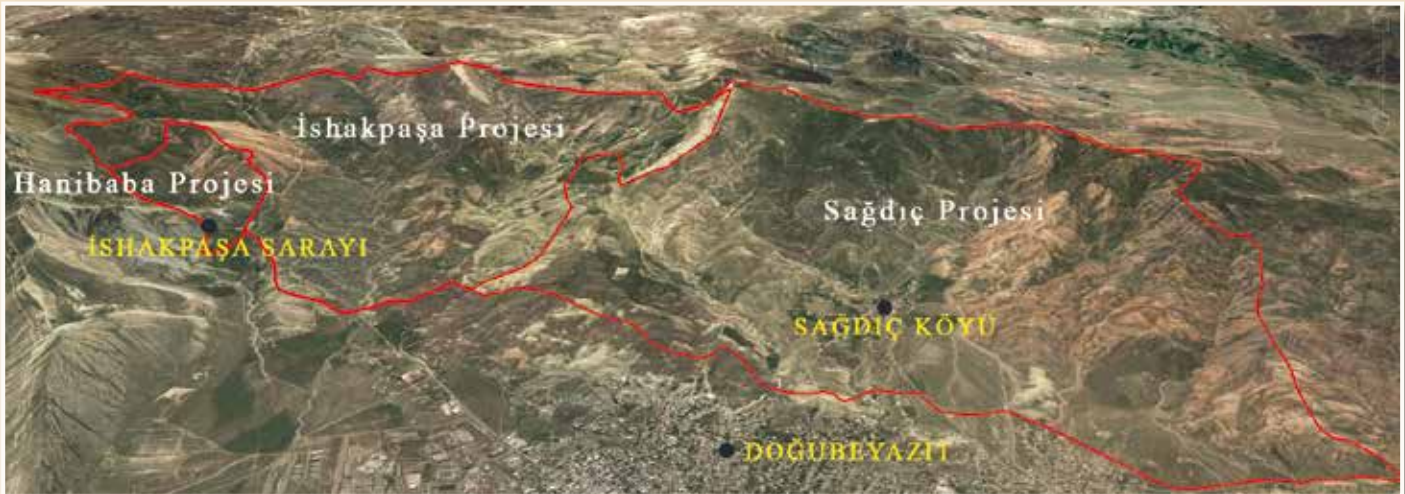
*The General View of the Project Site from the Highest Point of the Basin, Terraced to Rehabilitate Pasture Areas in 2013. Terraces increase the vegetation cover by keeping the precipitation water in the soil and provide soil and water conservation.*

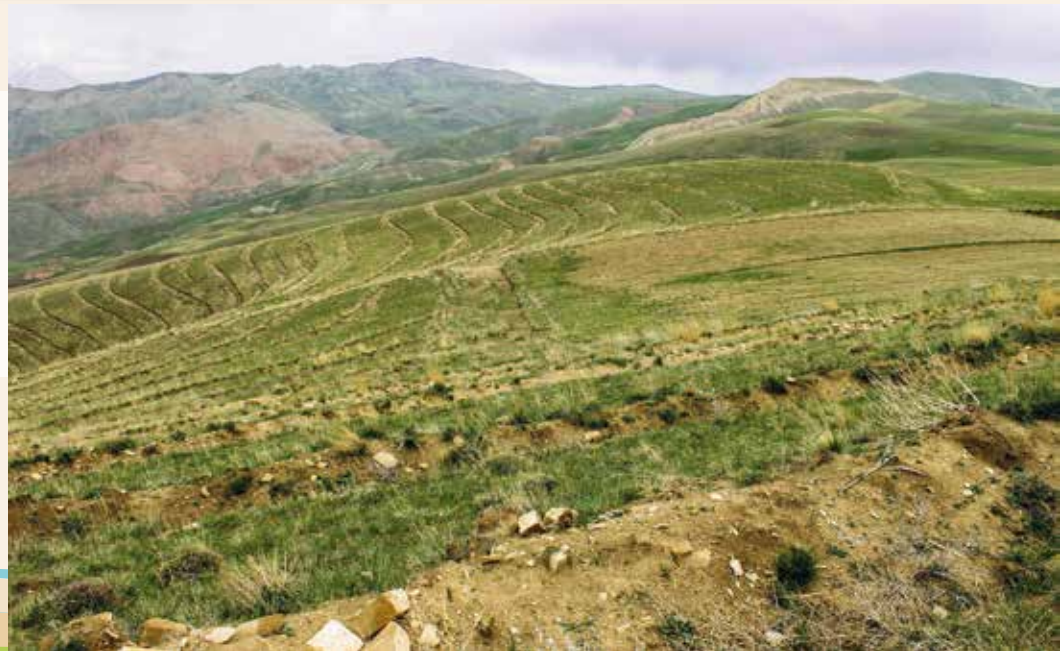
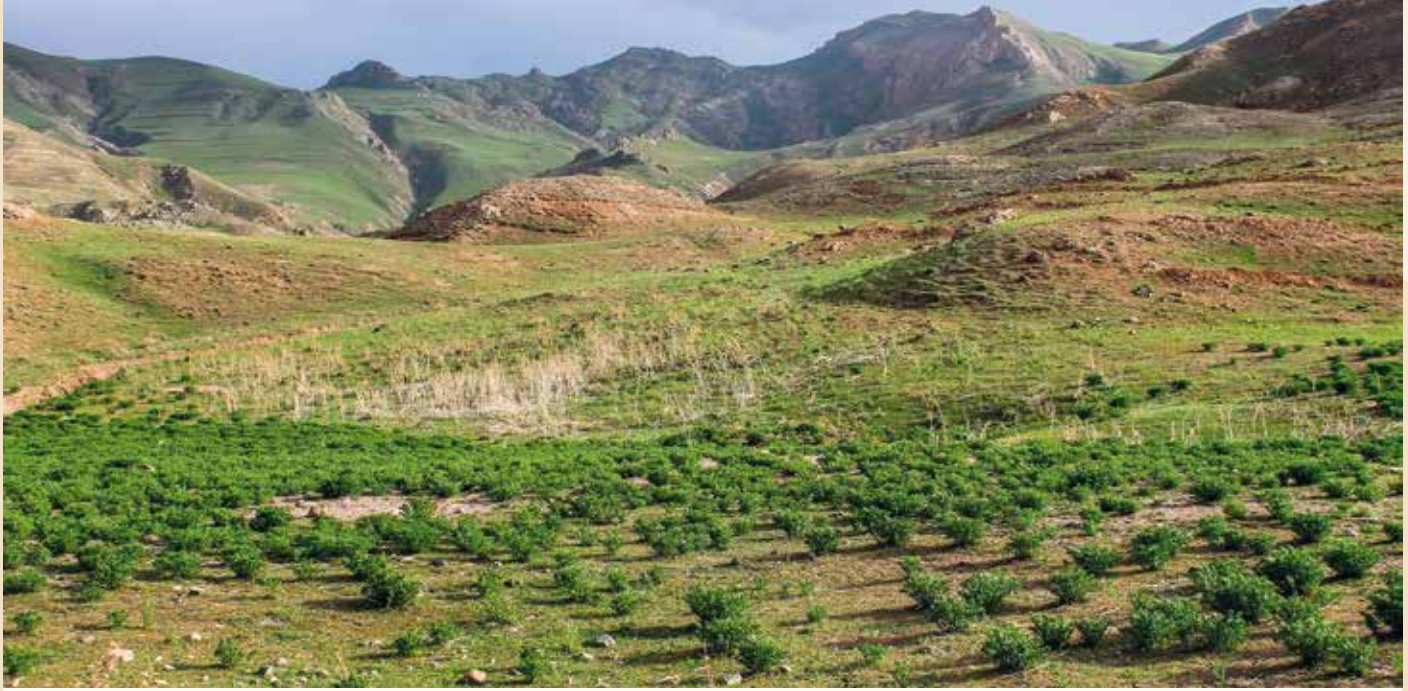
*Appearance of the Highest Area from the Lower Point of the Basin. In the Upper Part of the Micro Basin Through the Soil Conservation Facilities The lower parts of the basin are covered with vegetation cover.*

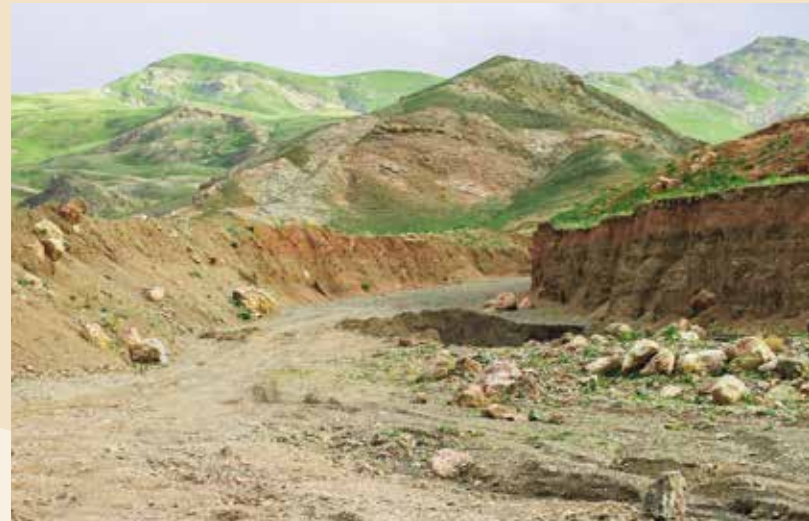
*the bed widths are 10-15 meters and the bed depths above 2 meters in the lower parts of the basin.*

The most important streams of the basins that cause the flood are Zengizor, Shalvar, Ziyaret, Hocatasi and Ganisipi. Although the bed widths are 3-4 meters at the top of these streams, these widths reach 15-20 meters and the bed depths reach 3 meters in the lower parts of the basin.

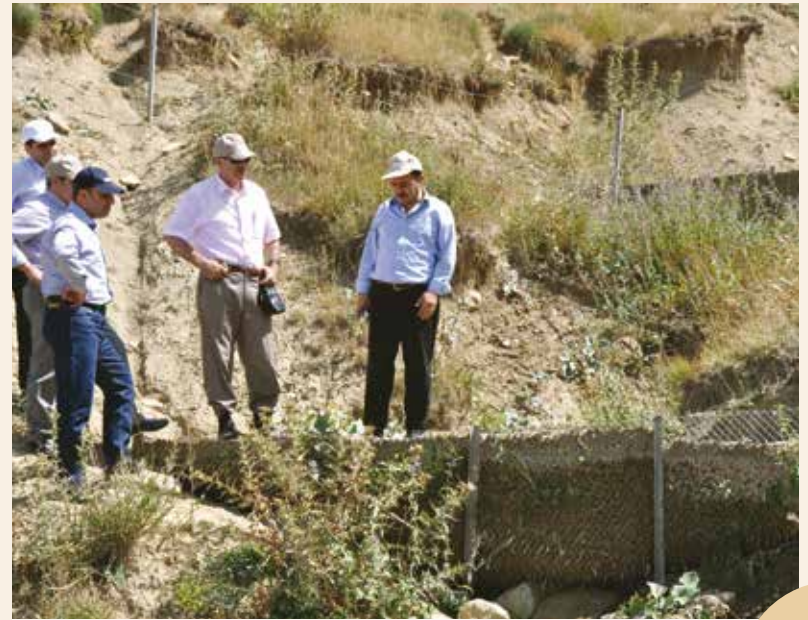
*Cage wire fence*

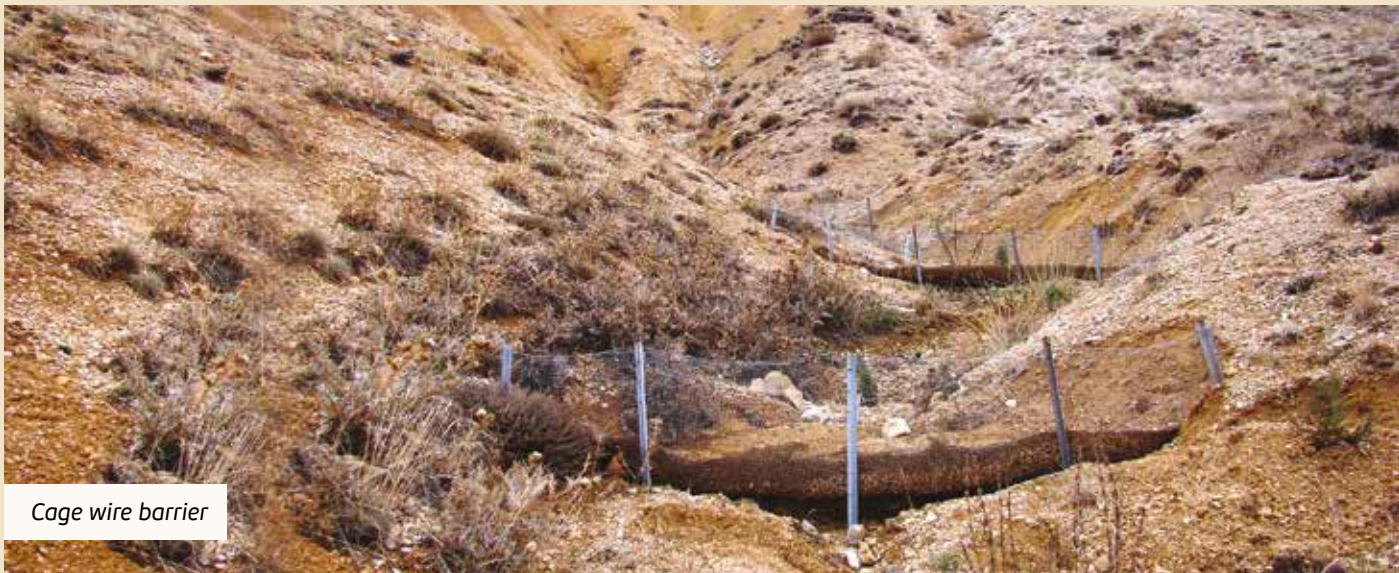
*Cage wire barrier*

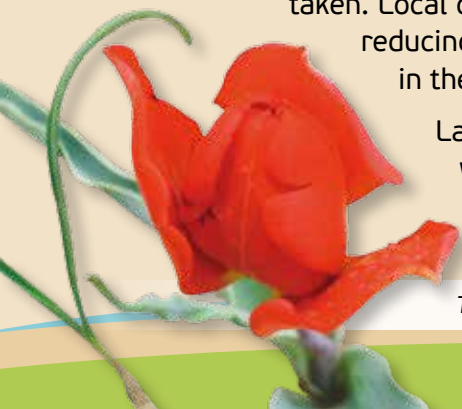
*The Biological Richness of the Basin has Increased in Protected Areas.*

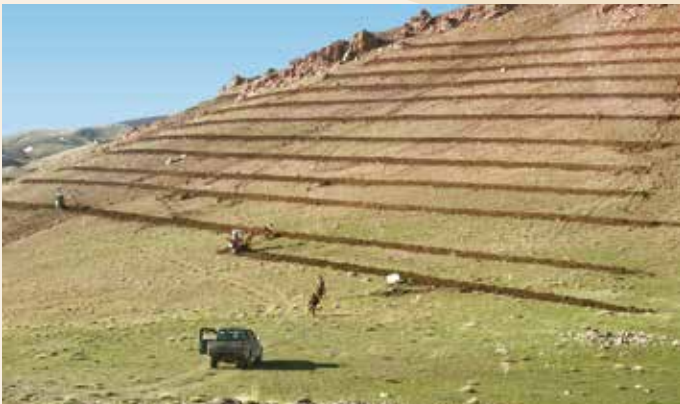
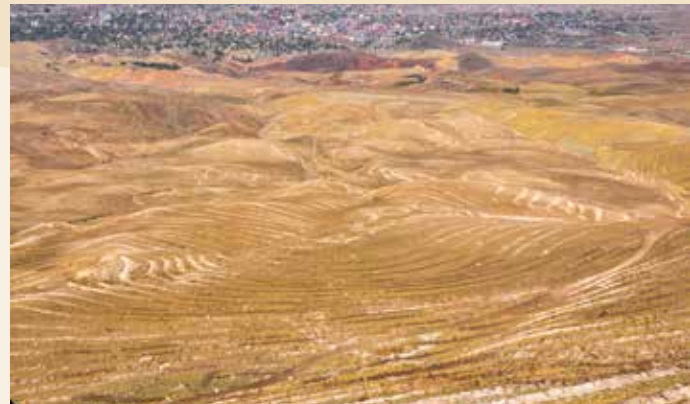
*Slope Rehabilitation with Suitable Excavation Terrace. Terraced terraces are inclined in order to prevent soil movement.*

The terraces were built to be 60-100 cm. in depth, 120-150 cm in width and a 25-30% inwards slope so that they would not hinder the grazing of the animals. They were built in such a way that there would be spaces between terraces, rather than a continuous terrace, and in a flattened shape rather than steep bumps, so as to facilitate the passage of animals.

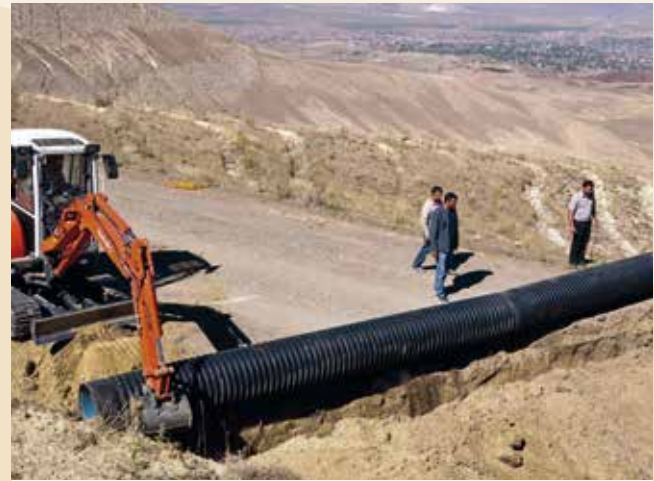
*The corrugated Pipe was placed on the roads.*

The corrugated pipes were placed in appropriate locations in order to prevent the slope waters from damaging the existing roads and the terraces which are below the roads.

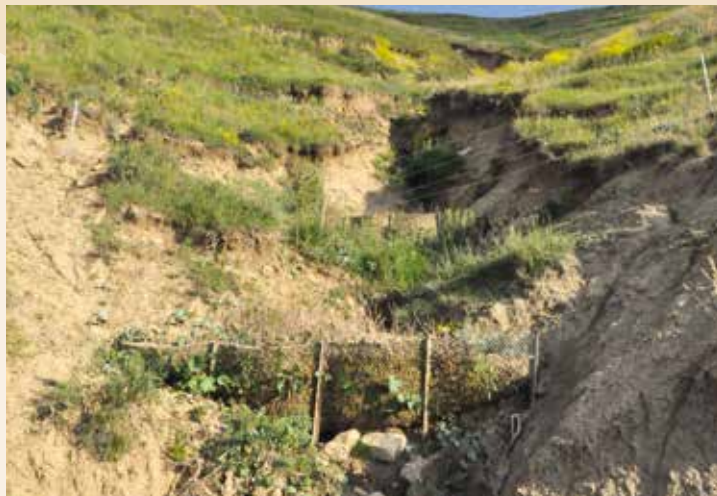
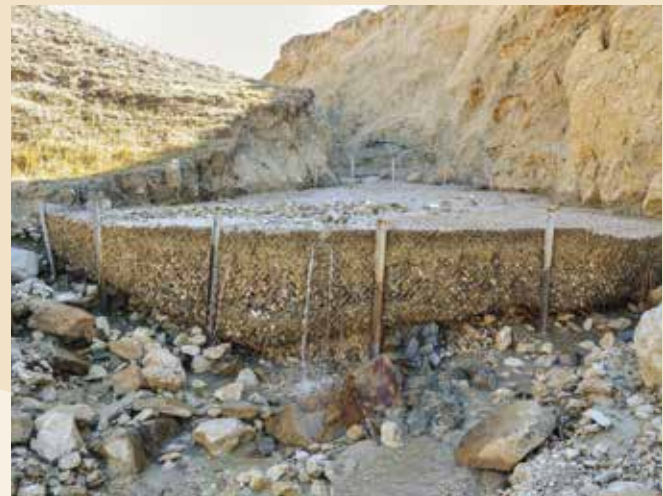
*Systematic lattice wire barrier prevents soil transporting in gullies*

Lattice (grid) wire barrier are constructed in gullies in equal intervals. Therefore, the feeding of main watercourses, which cause the floods, by tributary channels was reduced, and the destructive power of water was alleviated.

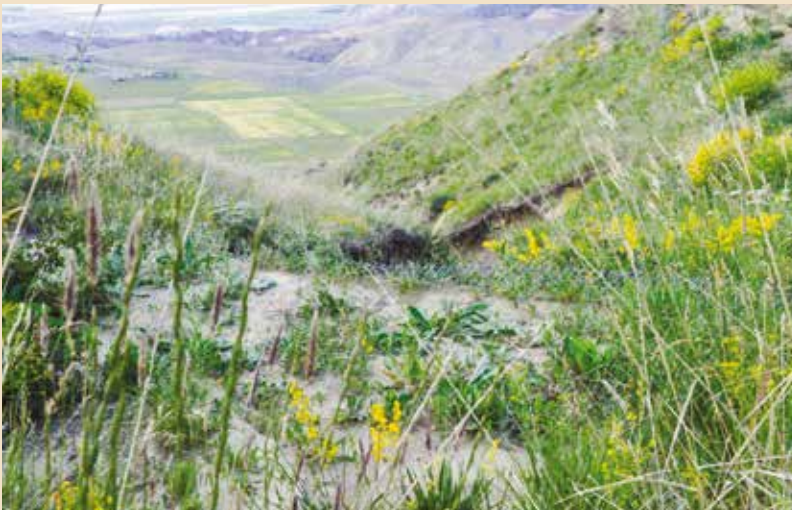
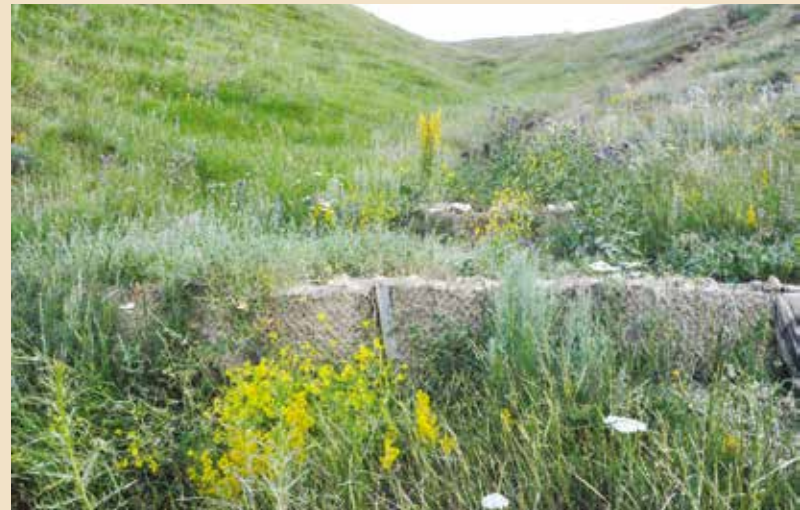
*Stabilised and green gullies where the rear of wire barriers are filled with transported sediments.*

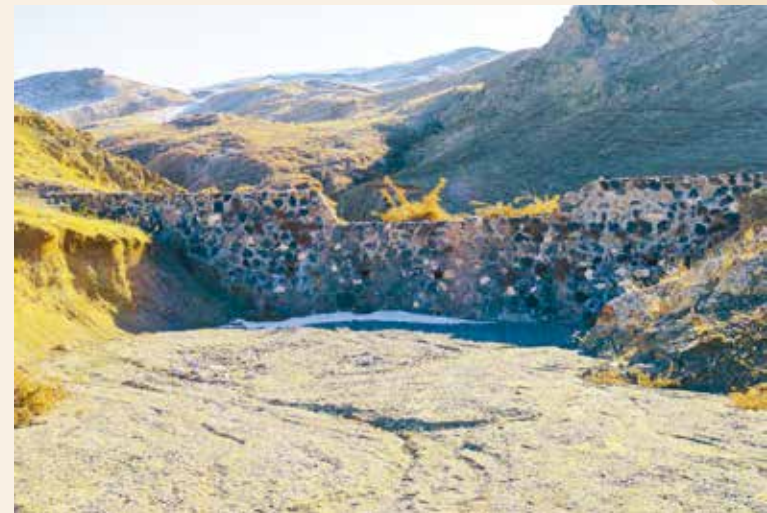
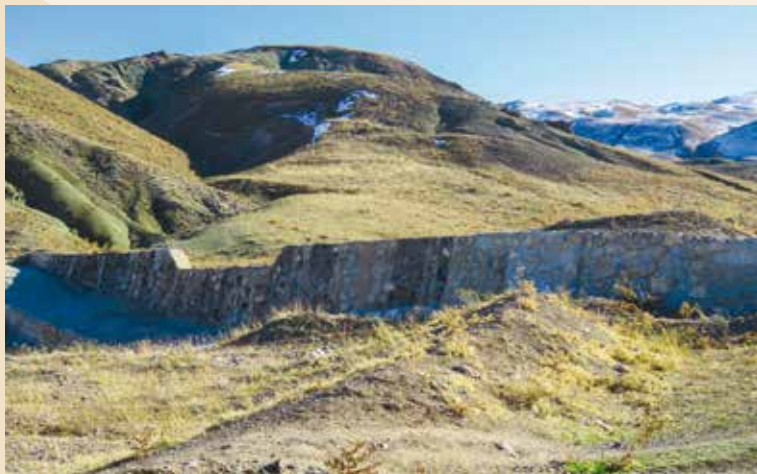
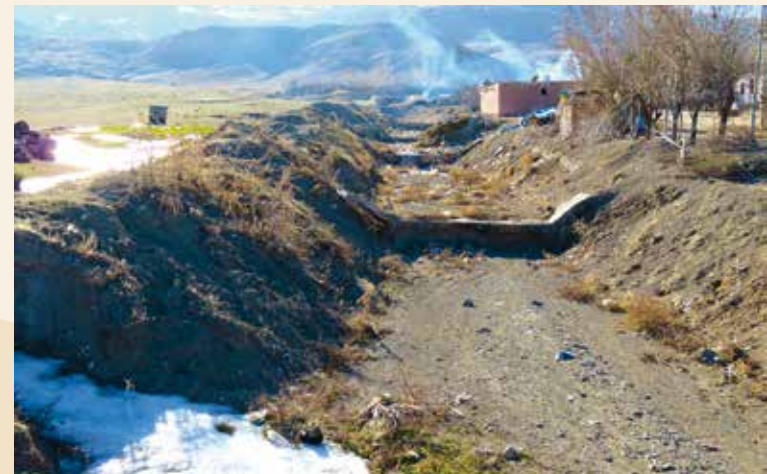
*Ground sills and check dams built at regular intervals in a streambed/Watercourse*

Ground sills, dwarf walls, check dams and sediment-storage dams were built in the watercourses in Doğubayazıt flood-prone basin.

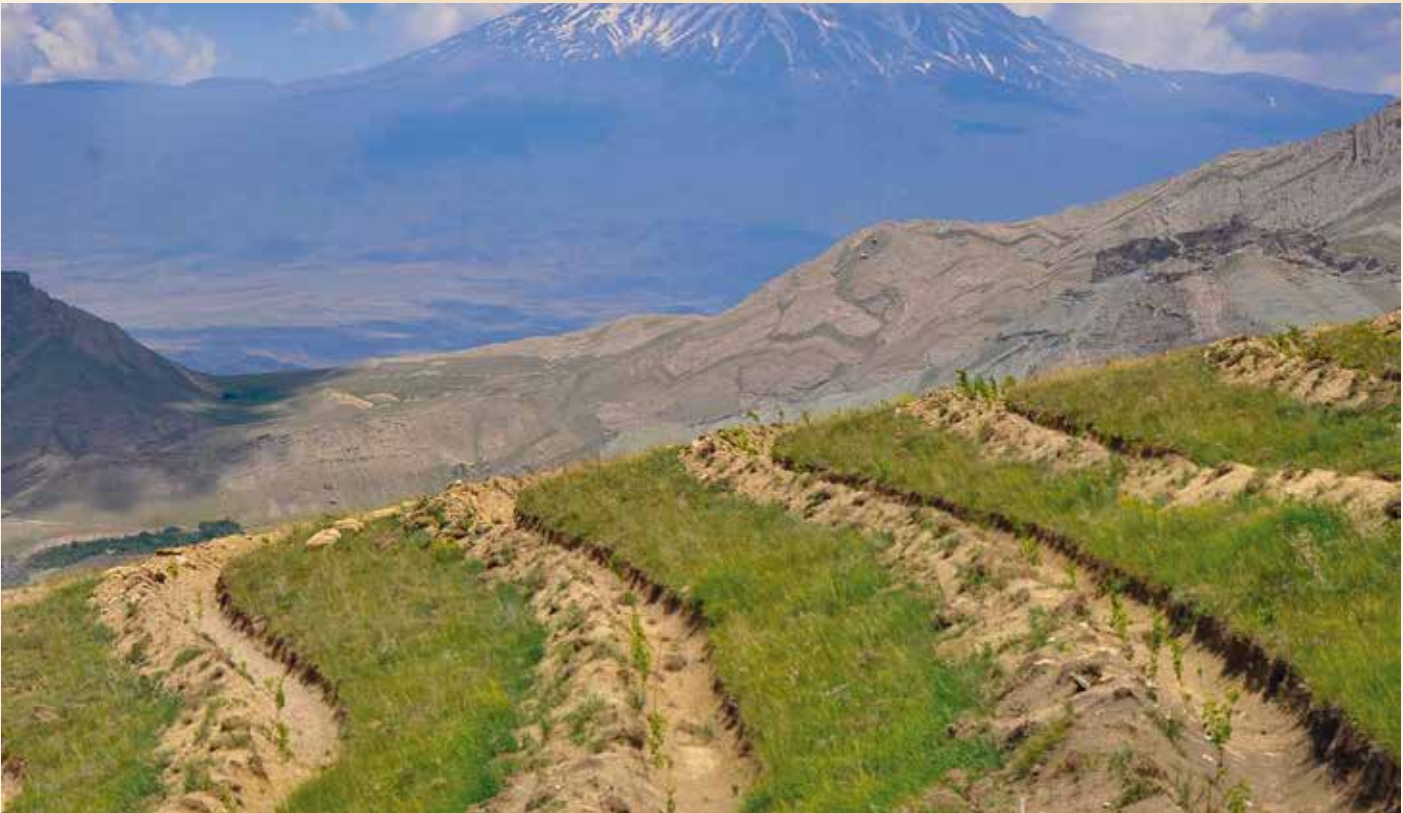
*Locally suitable species were planted on the İshakpaşa terraces*

At terraces on highly steep slopes where grazing is difficult or impossible, a total of 296,000 seedlings selected from locally suitable species (including Silverberry, Mahaleb, Berberis, Rosehip, and False Acacia) were planted on 575 hectares of land, of which 5 hectares is located in Hanibaba project site, and the remaining 570 hectares in İshakpaşa site. Despite the high-altitude, the survival and adaptation percentages of these seedlings is substantially high.
